Water Line Lakeview Ohio

Water Line Lake View

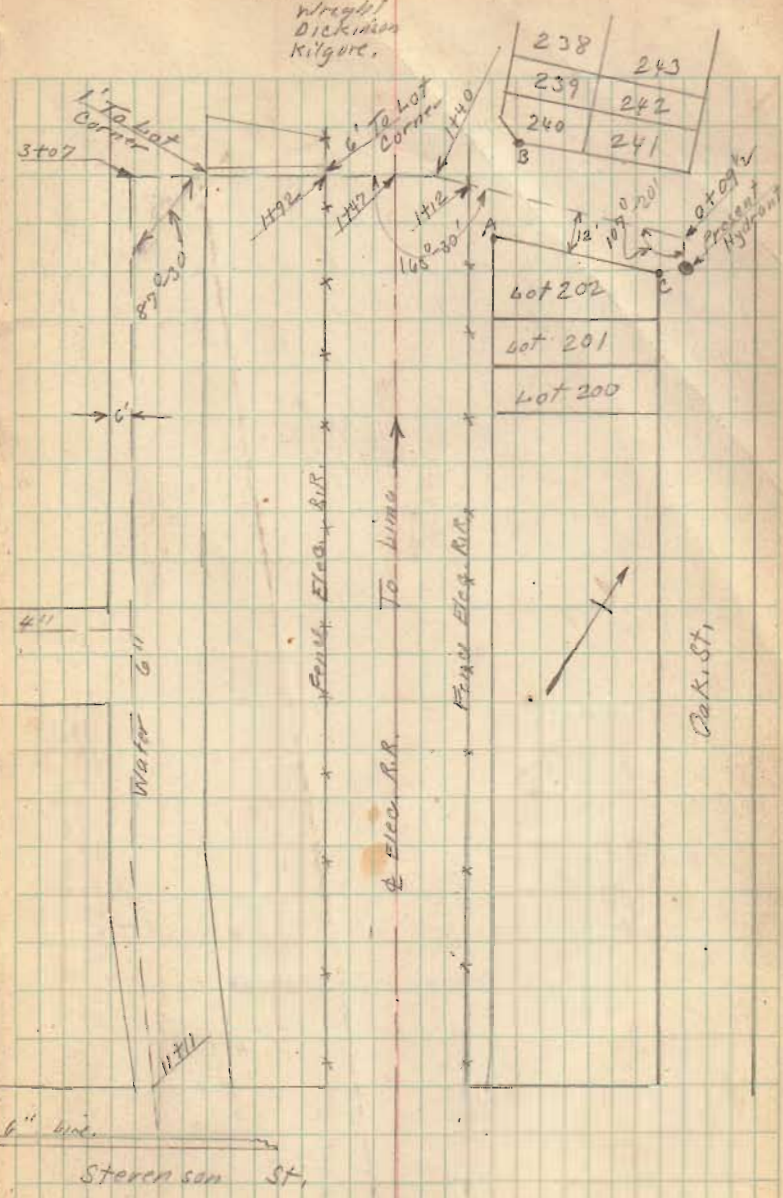
48

Hubs Placed 3' on Right
of Water Line.

See Page 49 for Witness
To Iron Pins.

1.C.H. Concrete Road
To Lima
